TRIDIMENSIONAL GPR MAPPING IN THE UPSTREAM FACE OF AN RCC DAM

Abstract. *Mapping with geophysical techniques such as the Ground Penetrating Radar (GPR) is based on the propagation of electromagnetic waves and has a wide range of applications in civil engineering. This work presents a non-destructive investigation with GPR in the conventional concrete face of a roller compacted concrete (RCC) dam. The objective is the identification of subsurface anomalies, such as niches of higher porosity in the conventional concrete, whose thickness is not greater than 50 cm. The acquisition of radargrams was carried out with a 2 GHz antenna with dual polarization, which allowed assembling a three-dimensional subsurface image from a single direction reading path. The images were treated with a specific package of filters for concrete surveys. After this post-processing, the group of images was integrated to form a block diagram. The interpretation of the whole block was performed with a controlled thickness slicing procedure for identification of anomalies within sound concrete. A general view of the investigated area is presented with the indication of anomalous regions which may require a loca

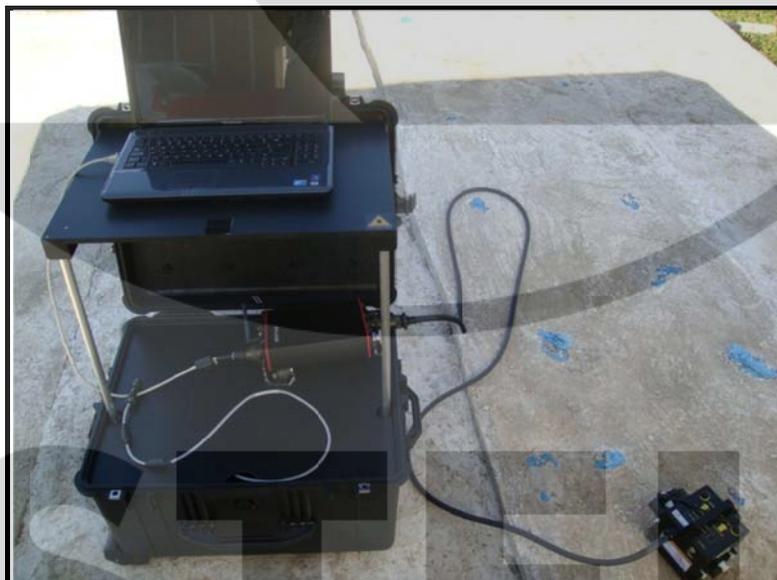
The equipment used in the present survey is shown in Figure 1. It has an interesting feature such as a dual polarized antenna (see Figure 2), which allows performing the data acquisition in only one direction. The 2 GHz frequency antenna allows a high resolution investigation, but with limited range, up to 50 cm in concrete.

Figure 1: GPR with dipole 2 GHz antenna.

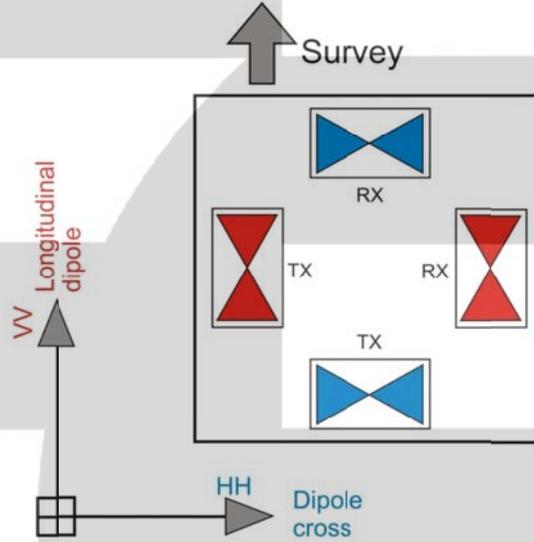
Figure 2: Layout of receivers (RX) and transmitters (TX) in a dipole antenna.

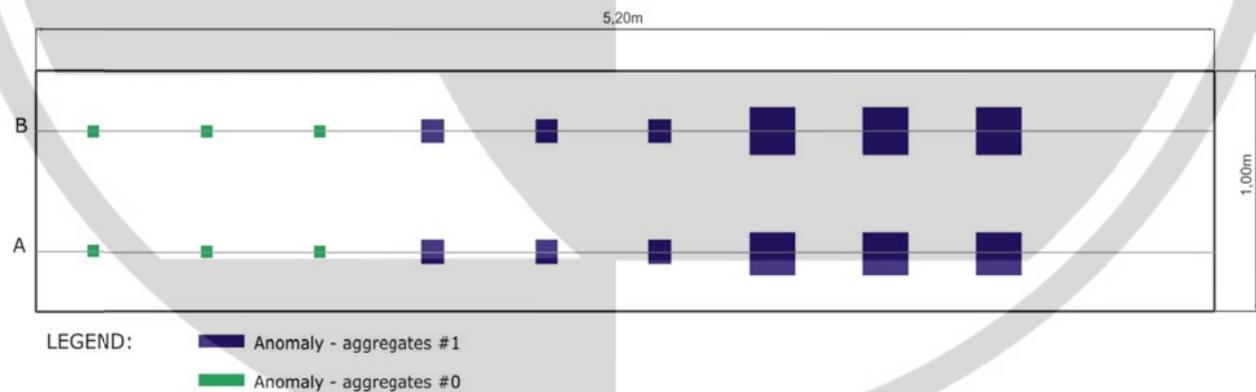
The construction plan consisted of a concrete block built in two steps with a minimum size for the GPR readings. The block was 5,20 m long, 1 m wide and had thickness of 0,50 m. Eighteen anomalies were inserted in a symmetric configuration, as shown in Figure 3. The anomalies had different areas and thicknesses and consisted of empty spaces filled with aggregates size 1 and 2, which were covered with a plastic film to ensure its higher porosity. The sizes of the anomalies were printed in the concrete using regular molds, as shown in Figure 4: Placement of the anomalies in the concrete block.

Figure 3: Schematic plan of the concrete block with the anomalies layout.

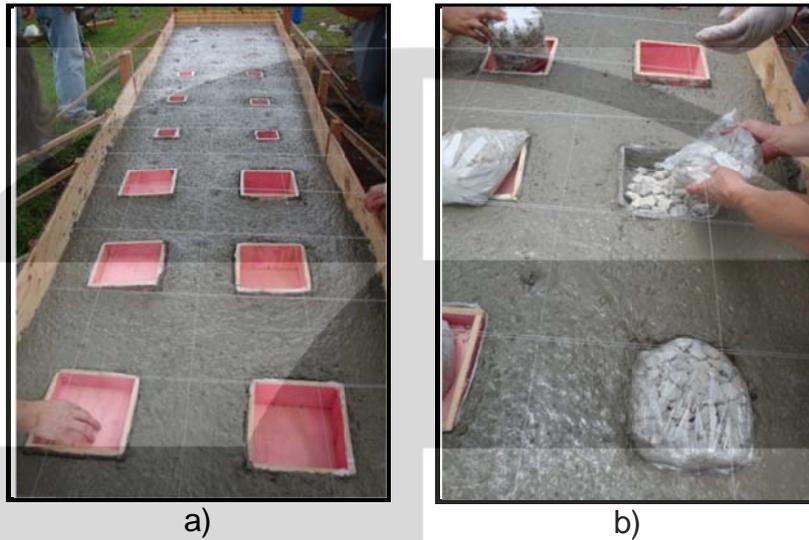
Figure 4: Placement of the anomalies in the concrete block.

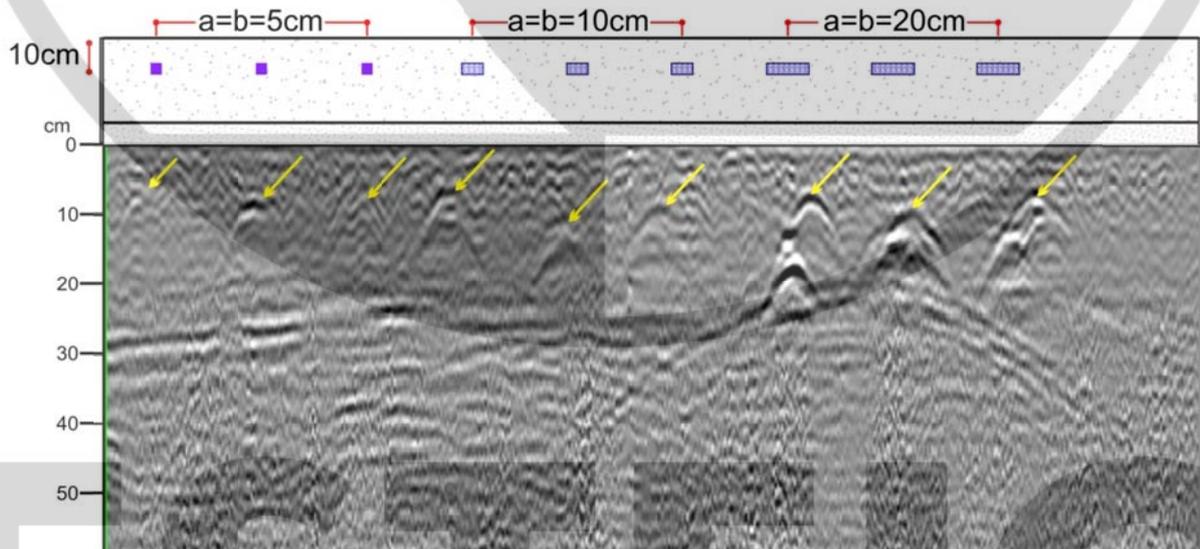
Two radargrams are shown in Figure 5 and Figure 6 along with a section view of the block at the reading line. The presence of all anomalies could be detected and are indicated by yellow arrows in each figure.

Larger anomalies show very strong hyperbolic signals in the images. Small anomalies are still detectable, but the signals are not so evident, especially from the less thick ones. In general, thicker anomalies show stronger signals.

Figure 5: Radargram of section A with 5 cm thick anomalies placed at a depth near to 10 cm.

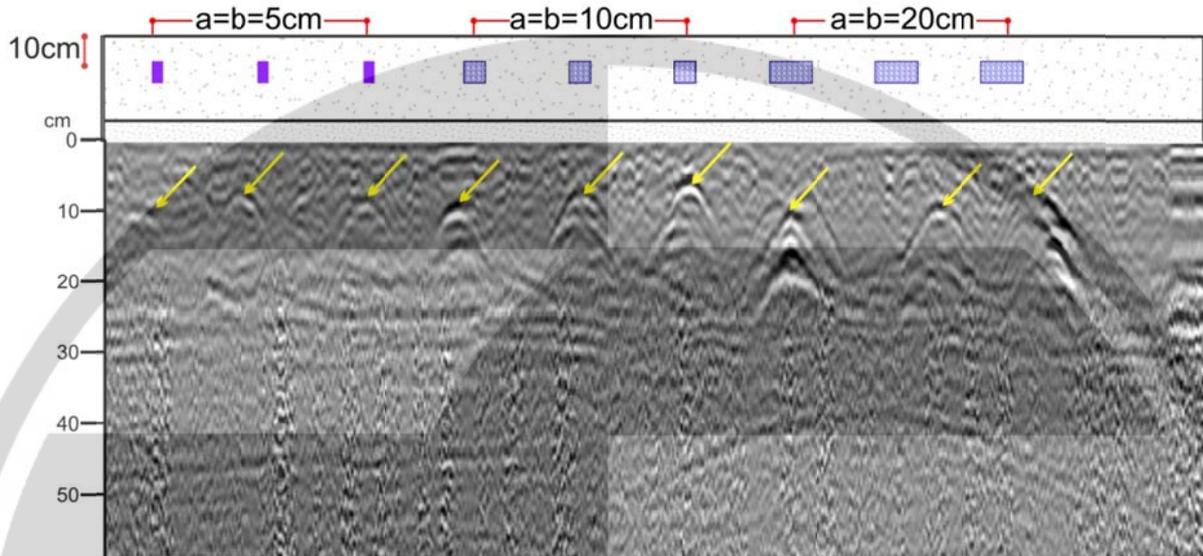
Figure 6: Radargram of section B with 10 cm thick anomalies placed at a depth near to 10 cm.

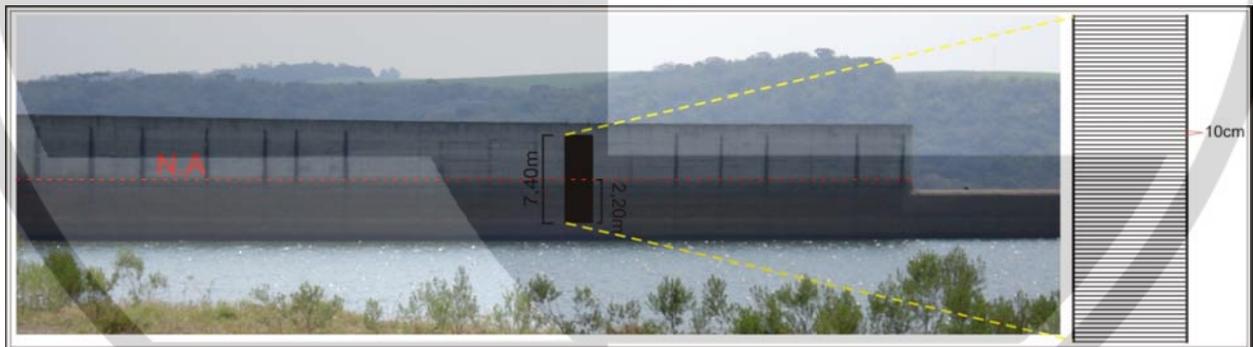
The GPR survey in Santa Clara was performed in a limited area of the upstream face of the dam (Figure 7), in order to evaluate the condition of the conventional concrete.

Figure 7: Location in the upstream face where the GPR survey was carried out – reading paths in the right side.

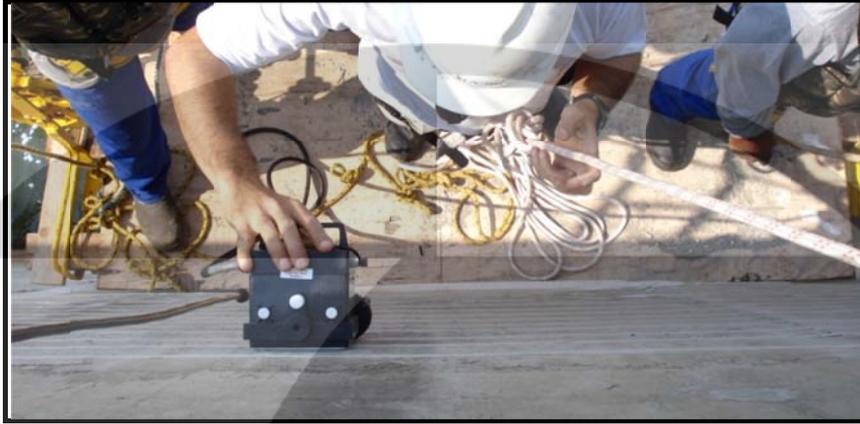
The selected area was discretized with 75 lines, 2,20 m long each one, with a 0,10 m spacing. Once the lines were marked, the GPR readings were done sweeping the antenna over each line, always in the same direction (Figure 8).

Figure 8: GPR survey in the upstream face with a 2 GHz dipole antenna.

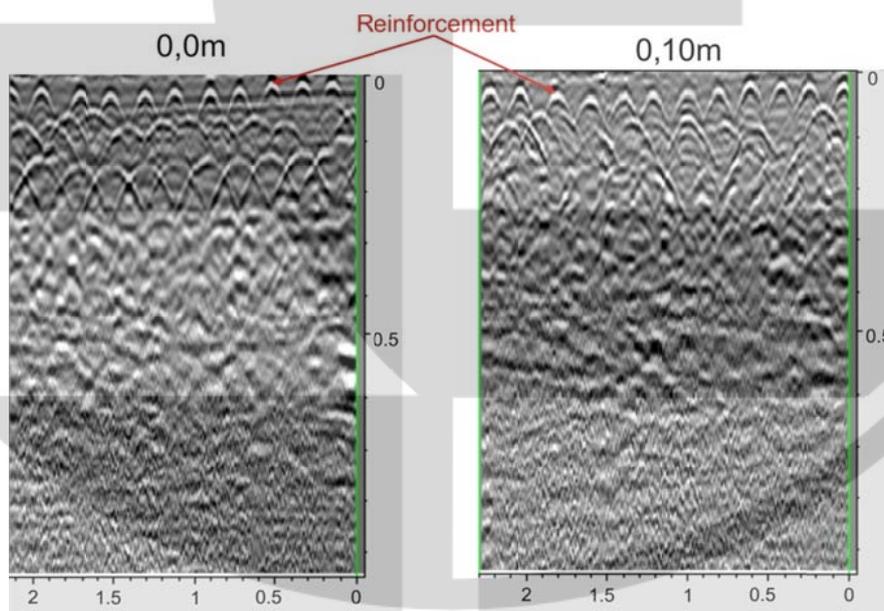
The first two profiles at the levels 0.0 and 0.10 m show striking reflectors in the form of regularly spaced hyperboles. This is a clear evidence of the concrete reinforcement at the pavement level (Figure 9).

Figure 9: Radargrams at the pavement level in the crest of the dam.

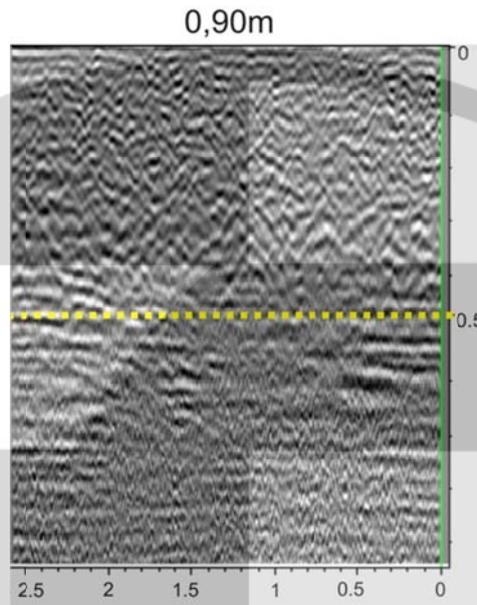
It is noticeable that beyond the depth of 0,50 m the signal quality is poor due to the high attenuation of the 2.0 GHz EM waves in the concrete. Beyond this depth noise masks the presence of reflectors, making data interpretation even more difficult (see Figure 10). Coincidentally, this depth is also associated to the transition between the conventional concrete and RCC.

Figure 10: Radargram showing noisy data beyond the depth of 0,50 m.

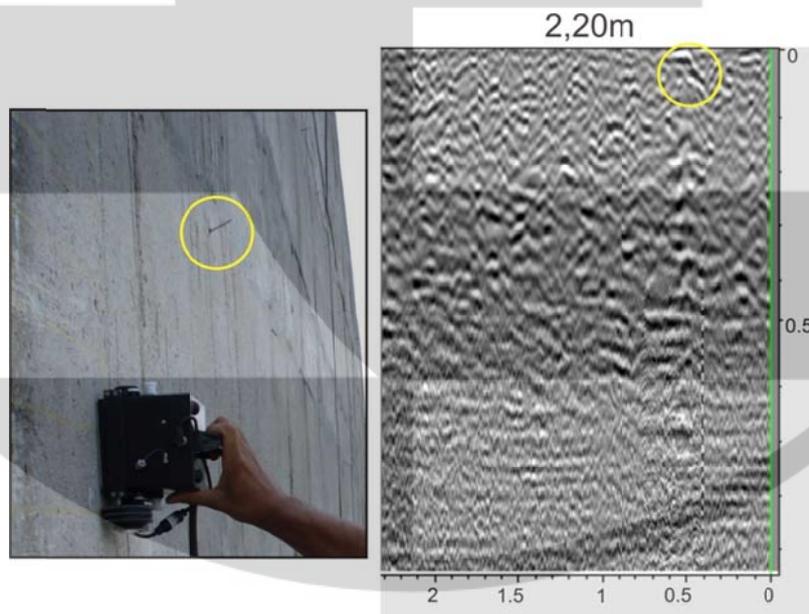
In some profiles it was noticed the presence of isolated hyperboles of small amplitude, which are associated with the occurrence of metallic fragments inside the conventional concrete as shown in Figure 11.

Figure 11: Presence of metal fragments in the face of the dam.

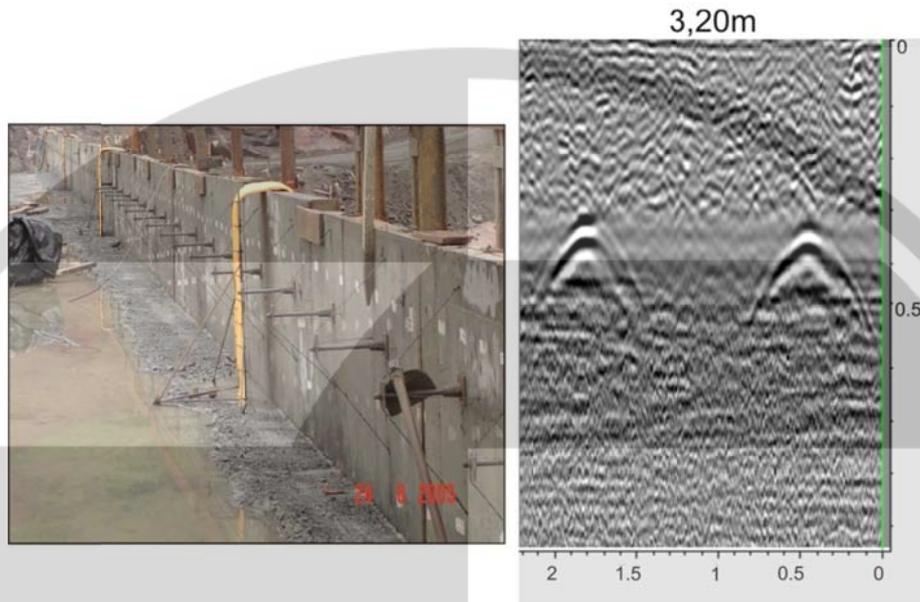
In specific radargrams there was the occurrence of striking hyperboles of greater magnitude, which are related to the presence of metal elements used to fasten the climbing forms during the concrete work. The forms are shown in Figure 12 alongside the radargram of the corresponding level.

Figure 12: Example of striking hyperboles (right) resulting from metal elements used to fix the forms (left) which were left embedded in concrete.

The GPR radargrams also revealed the presence of metal elements inside the conventional concrete zone, regularly spaced in vertical and horizontal directions, which were used for fastening the climbing forms during the dam construction.

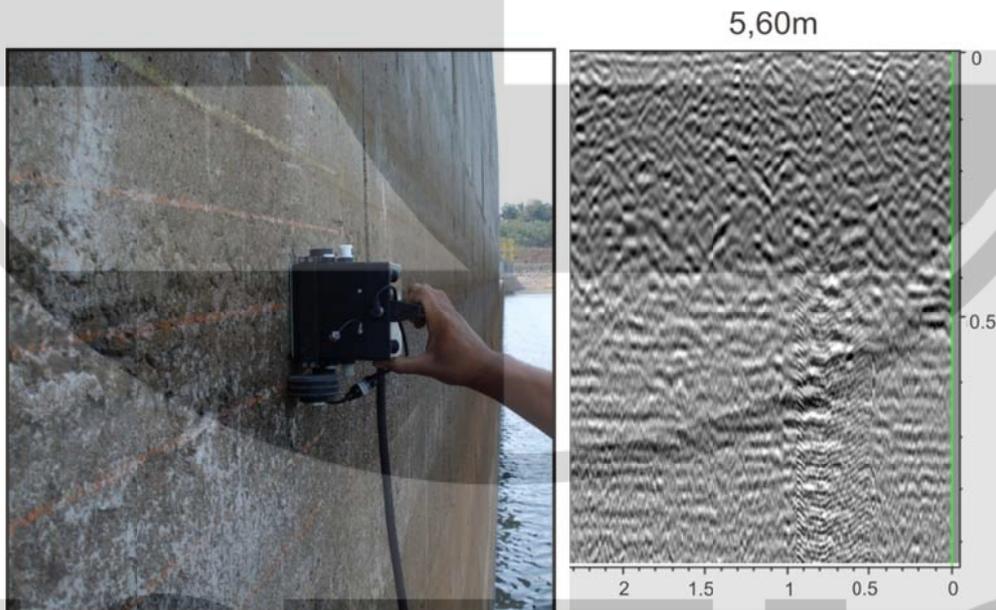
The GPR profiles along the lines just below the normal reservoir level showed increased presence of irregular and truncated reflectors, due to the irregular concrete surface with showing aggregates. Wear in this area is particularly high due to the water level fluctuations (Figure 13). None of these hiperboles detected in the radargrams are an indication of internal flaws.

Figure 13: Normal water level zone showing greater wear.

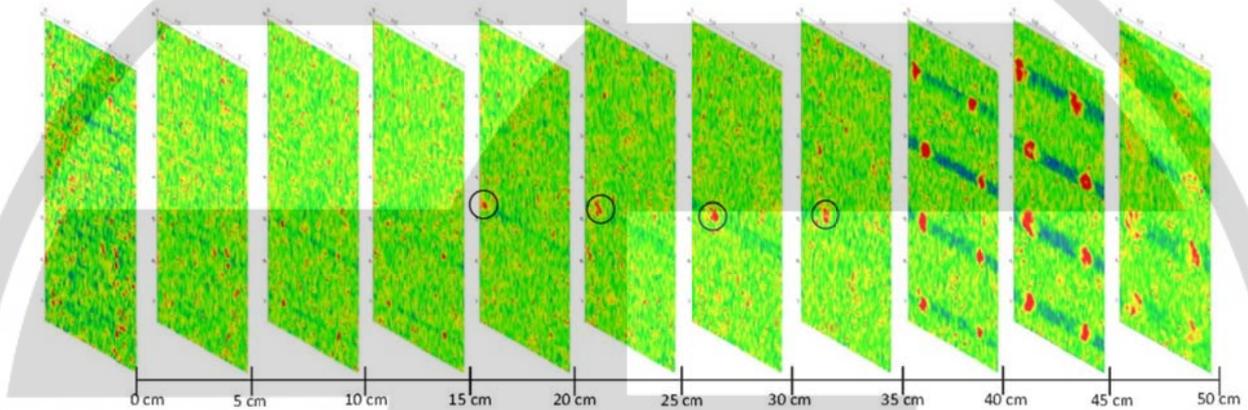
The product of this interpolation is a block, which after a 5 cm slicing, allows the identification of highly conductive areas, depicted in warm colors, and highly resistive areas in blue (Figure 14).

The metal elements used for fastening the climbing forms are clearly shown as well defined and equidistant spots of high conductivity between 40 cm and 45 cm depth.

Figure 14: 5 cm C-Scan of the mapped area. The circled areas indicate anomalies at various depths.

Voids or niches of higher porosity with high water quantity would also be indicated with red colors. In the surveyed volume the circled red spots detected from depth 20 cm to 35 cm, slightly above the 5,00 m level, is an evidence of one or more anomalies.

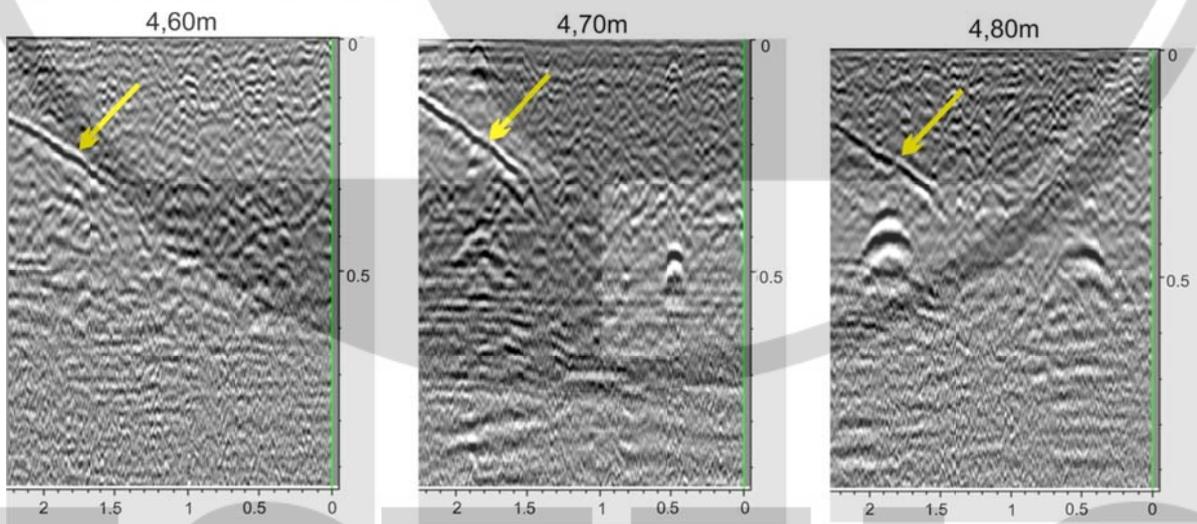
Looking at the radargrams between levels 4,60 m and 4,80 m, in Figure 15, the presence of a continuous plane anomaly in a diagonal position with respect to the face of the dam can be observed. The anomaly goes from 15 cm to 35 cm depth (Figure 14 and Figure 16 detail).

Figure 15: Radargrams at levels 4,60 m, 4,70 m and 4,80 m with the anomaly indicated.

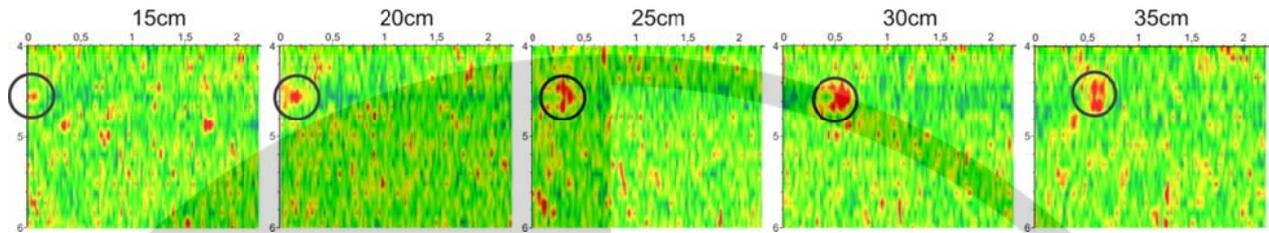
A closer look at the C-scan shows the anomaly in detail, which is over 80 cm long and ranges from depth 15 cm to 35 cm.

Figure 16: Detail of the C-scan with identified anomaly.

In the examined area of the upstream face of Santa Clara RCC dam, the GPR profiles revealed the presence of a plane anomaly inside the conventional concrete. Its location is above the normal reservoir level and the implementation of a refined inspection or corrective intervention was not justified.
